Bodie Island Life-Saving Station & Boat House

Historic Structure Report

Cape Hatteras National Seashore
Bodie Island Life- Saving Station & Boat House
Historic Structure Report

2005

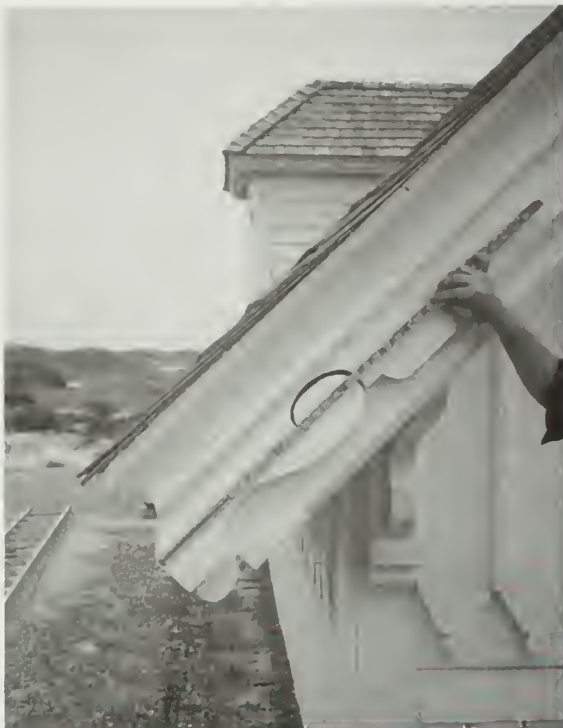
Figure C-7 Detail of fascia and rake boards

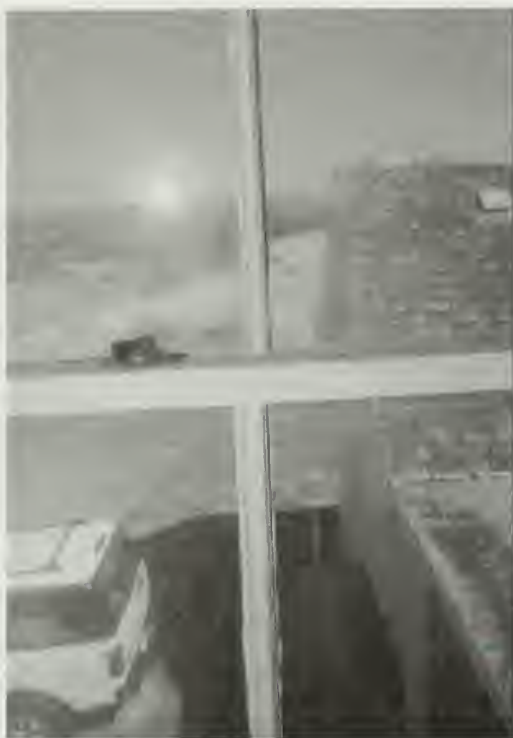
Figure C-16 Window muntins in Room 201

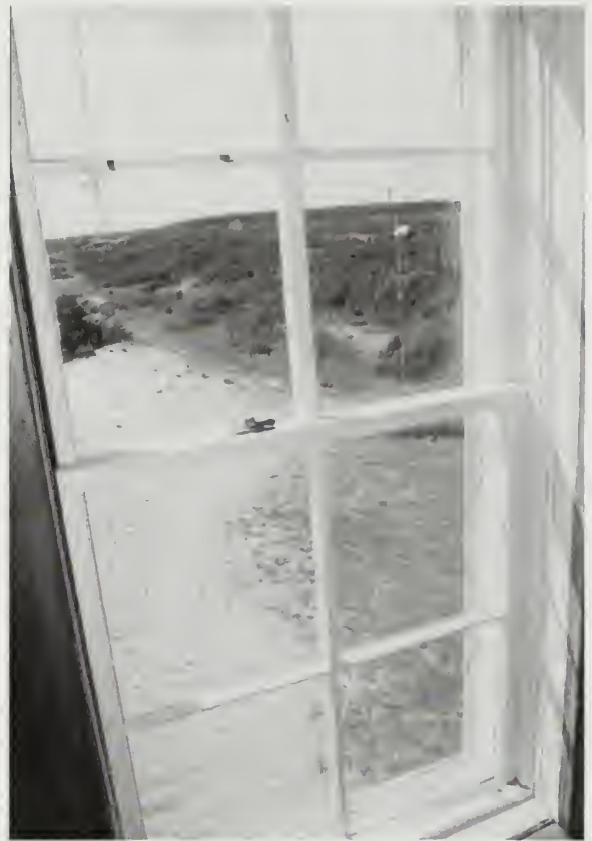
Figure C-19 Window muntins in Room 204A

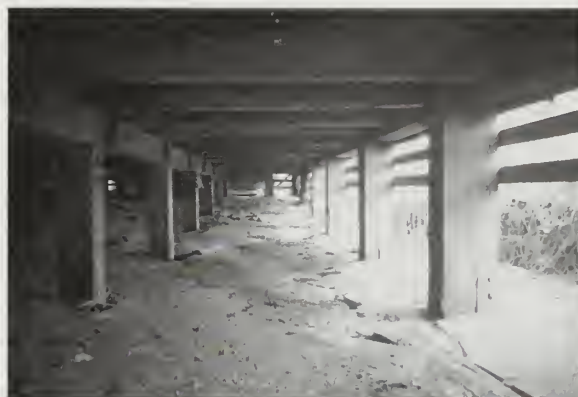
Figure C-22 Foundation and floor structure of the boat house, looking west

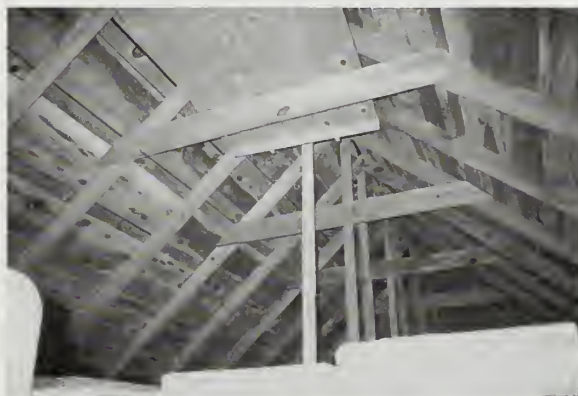
Figure C-23 Attic of boat house

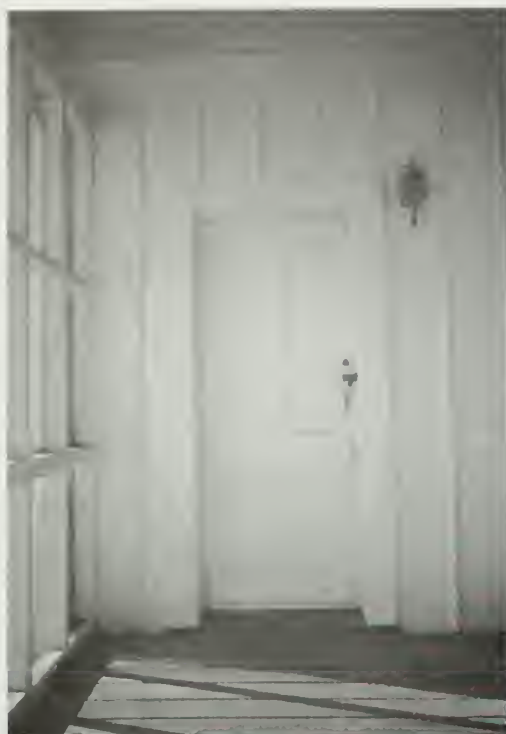
Figure C-25 Door on south elevation of boat house

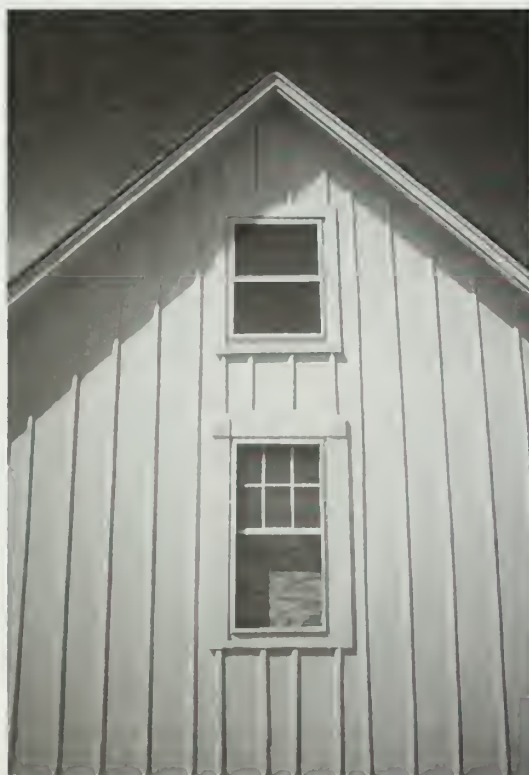
Figure C-26 Windows on east elevation of boat house

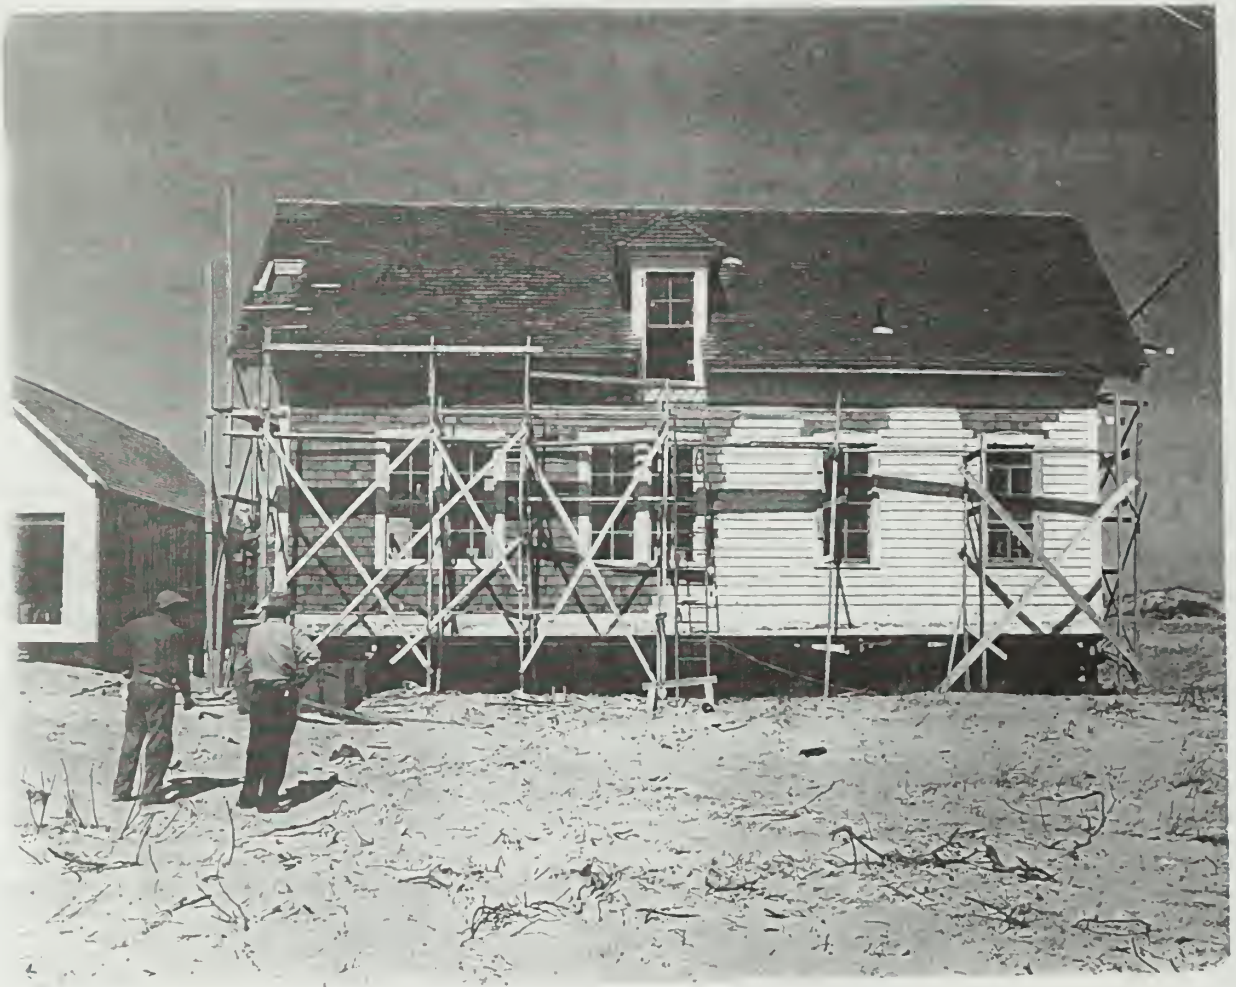
I.22 1879 Station from the west ca. May 1955. Shows new windows and patching of siding, also 1916 boat house relocated.

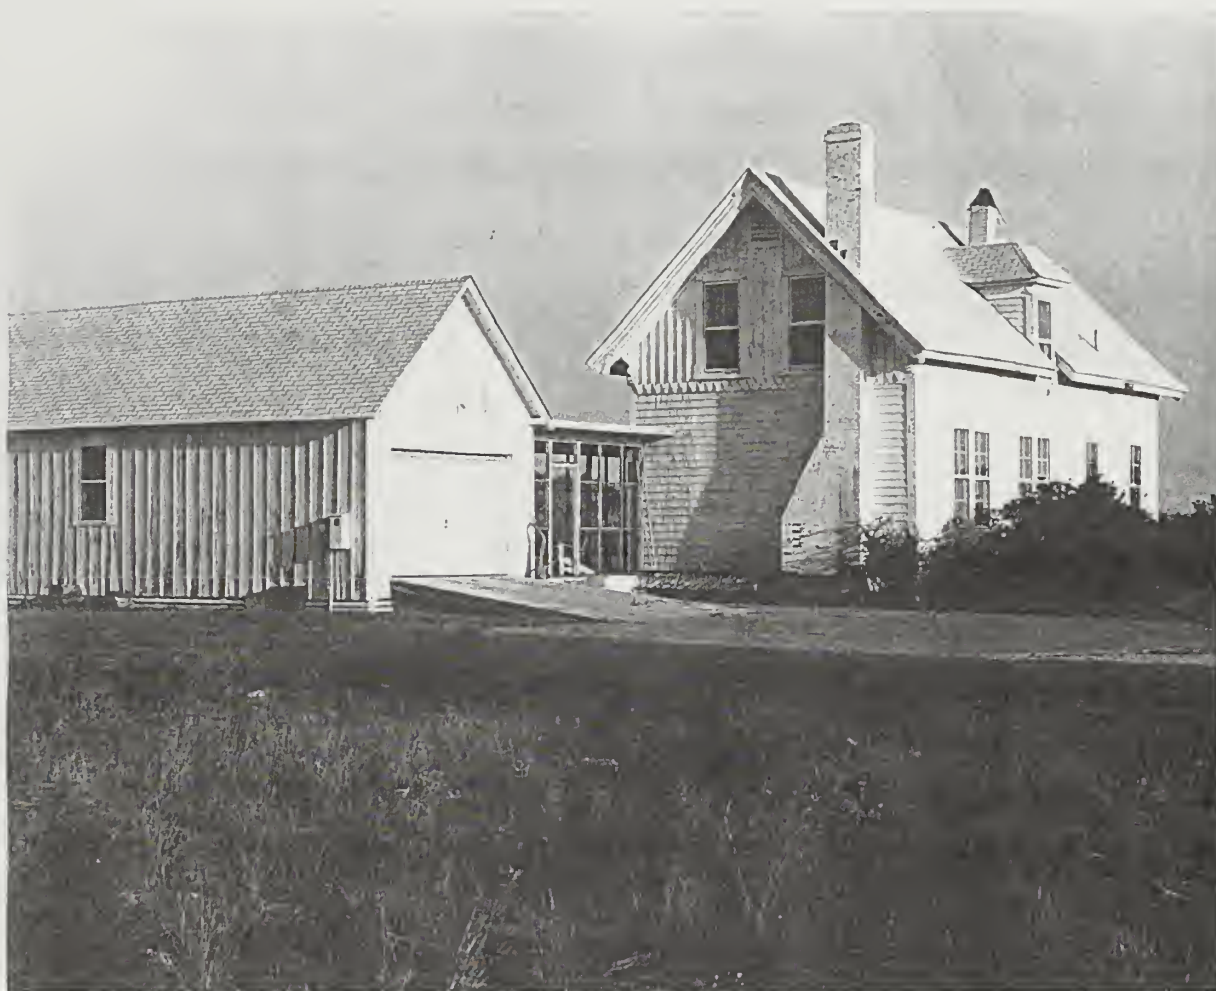
- I.23 1879 Station with 1916 boat house from the northwest ca. 1956. Shows completed relocation and renovation. Visible patching of original northern windows and new exterior chimney.
